PROCEEDINGS OF
THE INSTITUTION OF
CIVIL ENGINEERS

Ground-penetrating radar survey to detect sub-slab voids beneath the East Promenade at Rhyl

D. Nichol and J. M. Reynolds

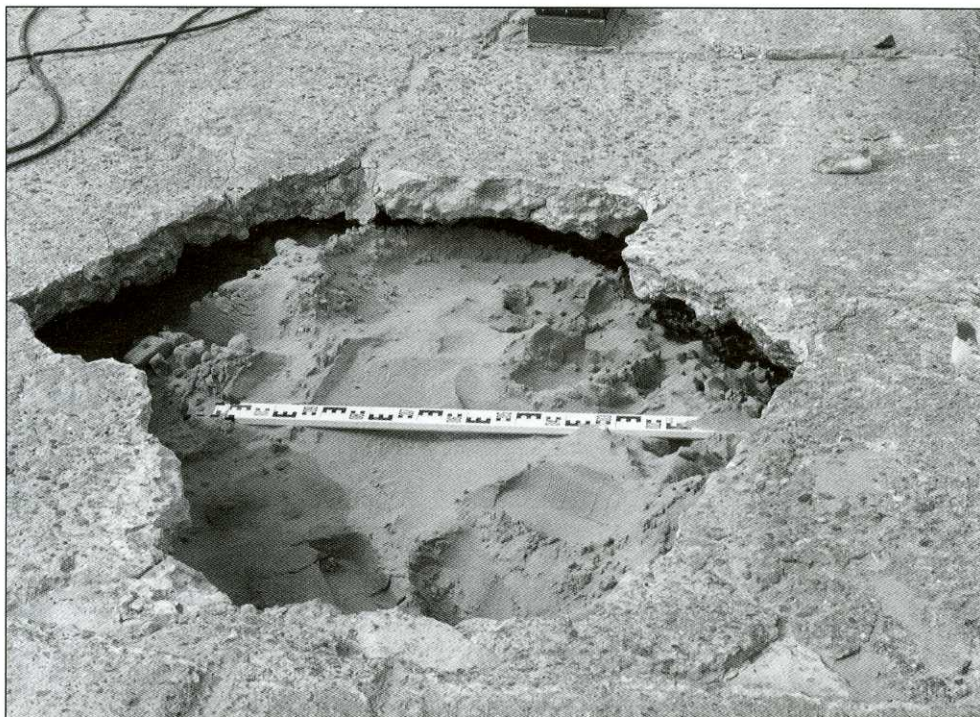
On 9 April 1998, a segment of the East Promenade failed spectacularly during a maintenance programme. The collapse revealed the existence of a major cavity below the run-

ning surface of the promenade. The hole in the slab measured 1.8×2.2 m and the void ranged up to about 1.5 m deep (Fig. 3).

Fig. 3. Collapse feature (after infilling with sand for reasons of safety) on East Promenade, Rhyl, 17 April 1998. Photograph by Douglas Nichol

The findings of the survey redirected attention onto the original collapse and the reasons behind the event. On the basis of concrete slab thicknesses revealed by the ground-penetrating radar as well as direct measurements, the slab at the collapse site varied up to 0.15 m thick compared with a typical thickness of about 0.2 m elsewhere along the promenade. Moreover, the slab at the collapse site seemed somewhat friable and at a more advanced stage of deterioration than that elsewhere along the promenade. Accordingly, the collapse may be attributable to a combination of

- (a) thinned concrete
- (b) cracked rotten concrete
- (c) the presence of the sub-slab void.

Remedial works carried out on the known cavity involved demolition and removal of the damaged slab, excavation of loose infilling materials and replacement with compacted sand and finally, construction of a new concrete slab incorporating steel mesh reinforcement.

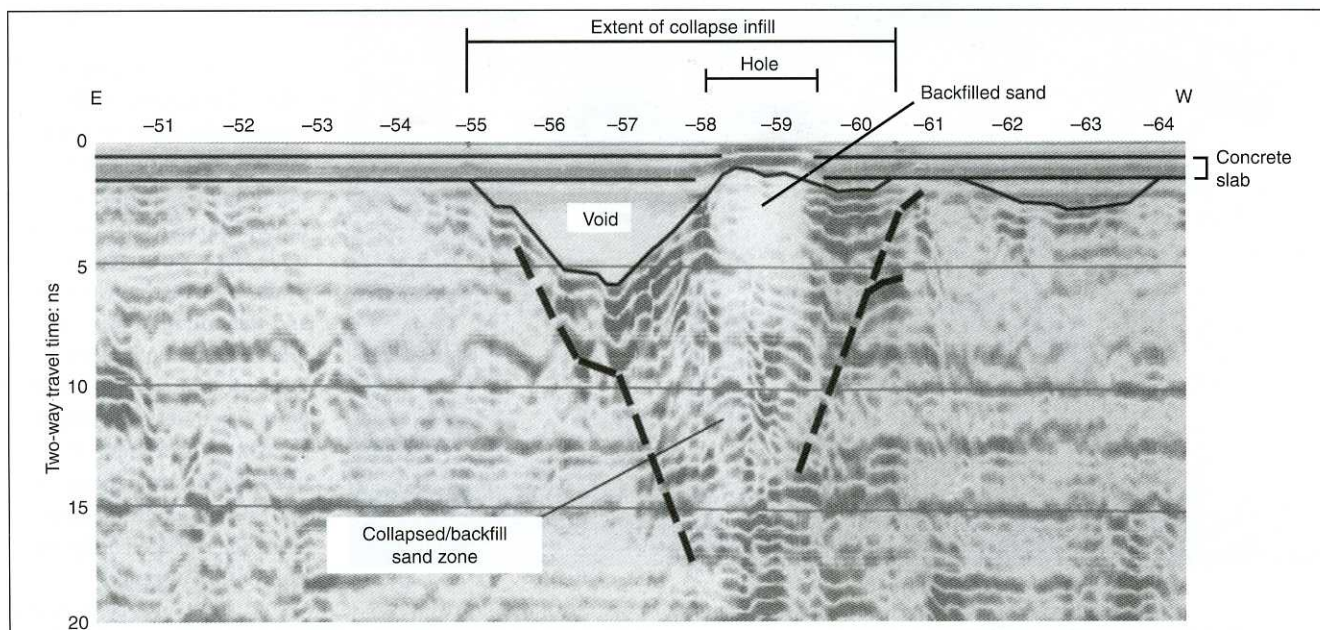
Fig. 5. Radargram section 0.5 m from edge of promenade at position -50 m to -64 m

The radargrams generated at the collapse site depict a uniform, featureless signal that corresponds with the air-filled void (Fig. 5). In addition, the pile of loose sand backtipped into the hole forms a conspicuous anomaly. Several bright reflections appear below the cavity and probably represent structures associated with subsidence of the original sand mass. A second, smaller void is also evident between -61 m and -64 m.

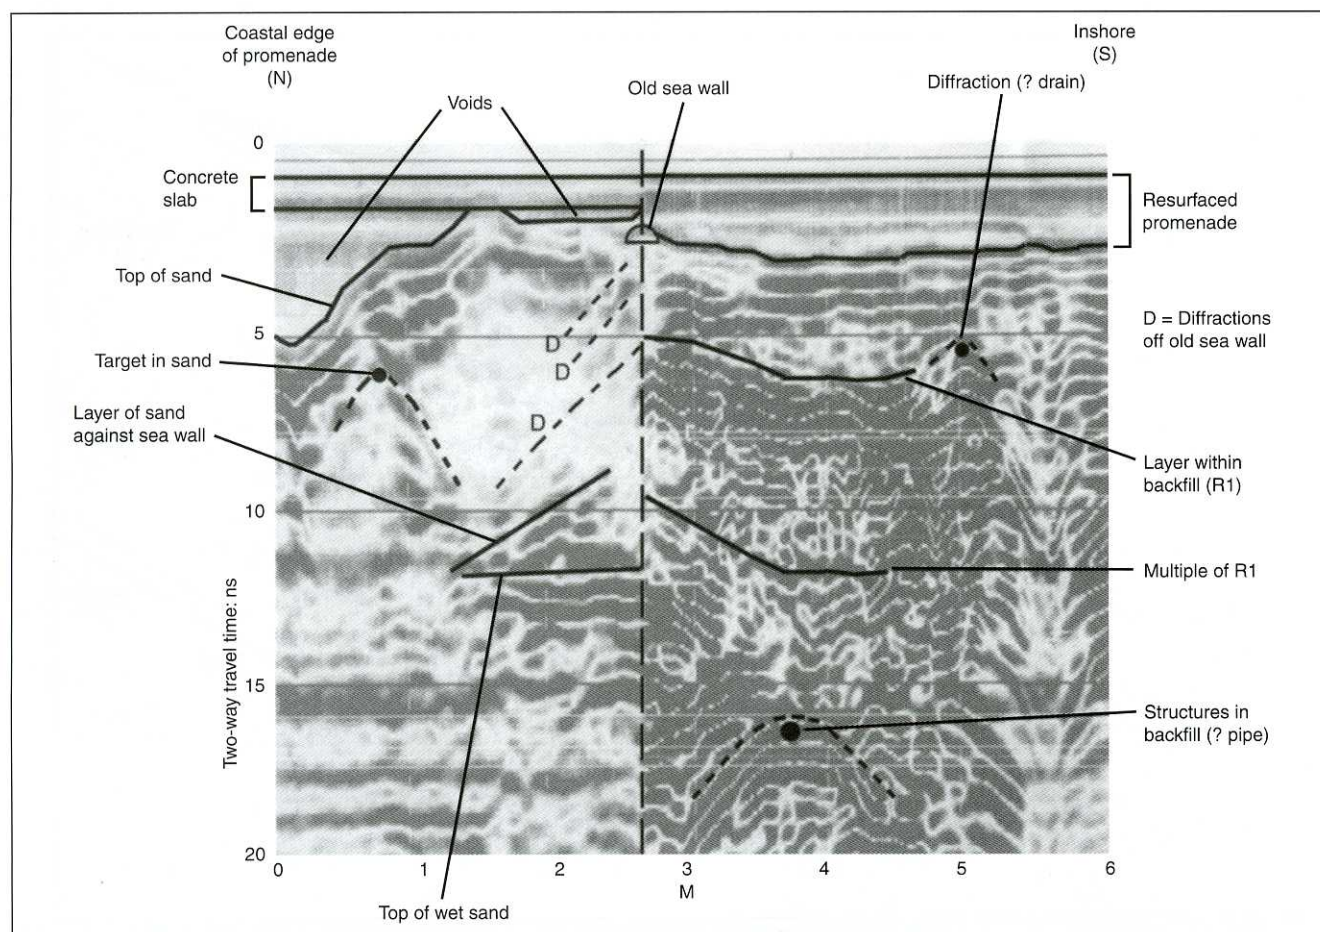
Fig. 6. Transverse radargram section at position -57 m

The transverse radargrams across the area with the known cavity also distinguish the air-filled voids as well as revealing details of the ground behind the original sea wall (Fig. 6). The character of the radargrams diversifies in the vicinity of the old

sea wall and several features are noteworthy. From the surface, the ground-coupled waves change form and lengthen relative to that in the rotten concrete, and the deeper areas to the south of the old sea wall display greater reflectivity than the sand mass to the north. In addition, the presence of the old sea wall generated a series of diffractions (labelled D in Fig. 6) and two intense reflections. The topmost reflection inclines upward towards the sea wall and resembles an accumulation of sand banked up against the wall. The lower reflection appears flatter and may be due to wet sand. Finally, strong diffractions occur at about 1.1 and 2.3 m south of the old sea wall and indicate the presence of internal structures such as drains or pipes.

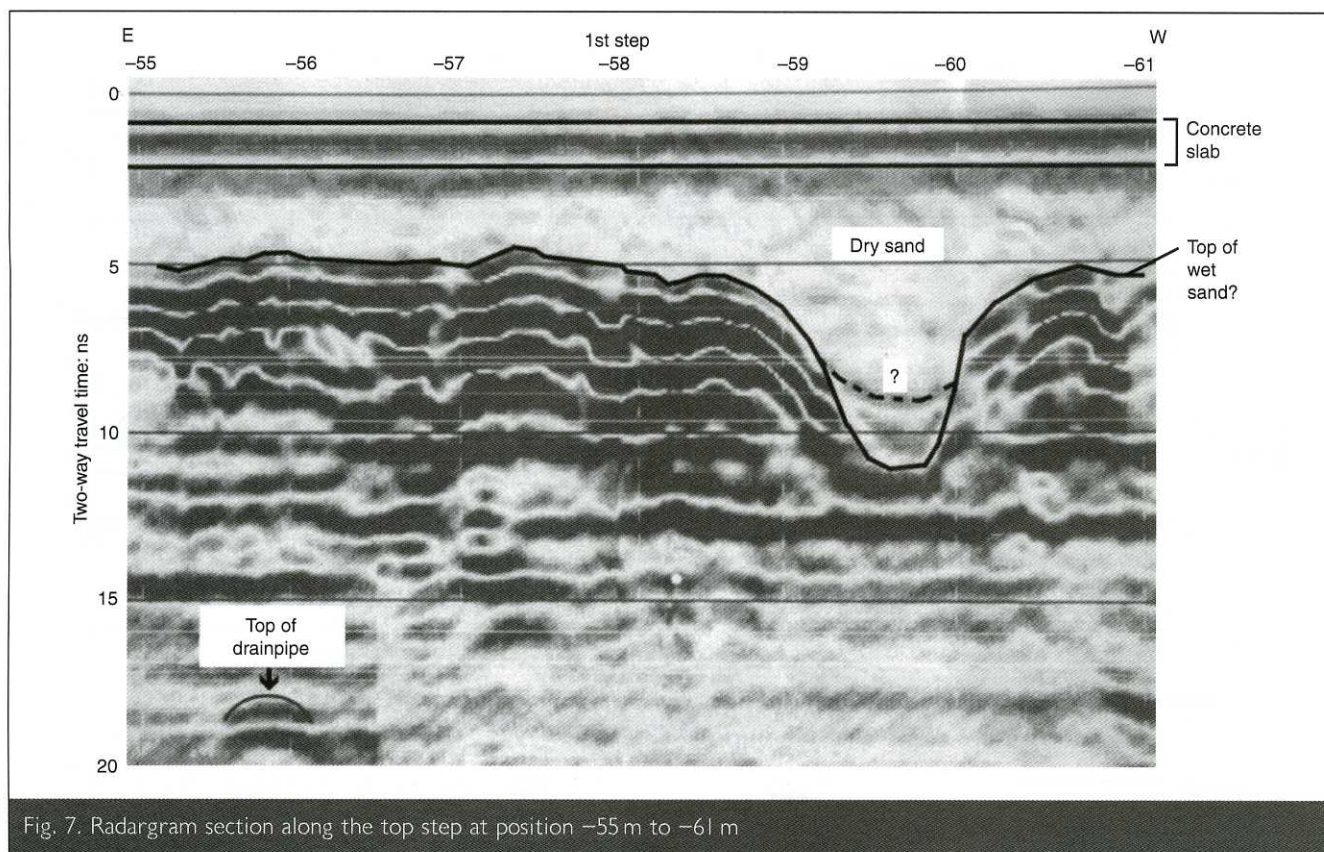
To delimit the known cavity, five supplementary radargrams were acquired along a short stretch of the steps (-55 m to -61 m) adjacent to the existing hole. Fig. 7 illustrates the radargram obtained along the top step. The concrete steps measure approximately 0.1 m thick. They are underlain by a featureless zone that is interpreted as dry sand. A marked reflection on the radargrams at TWTT of 5 ns is interpreted as the top of wet or damp sand. A peculiar depression appears between -59 m and -60.5 m on all of the radargrams acquired over the steps. Its physical significance remains uncertain. Finally, a strong diffraction exists on the radargrams at depth at -55.8 m and correlates with a known 0.2 m diameter drainpipe that discharges through the seventh step from the top.

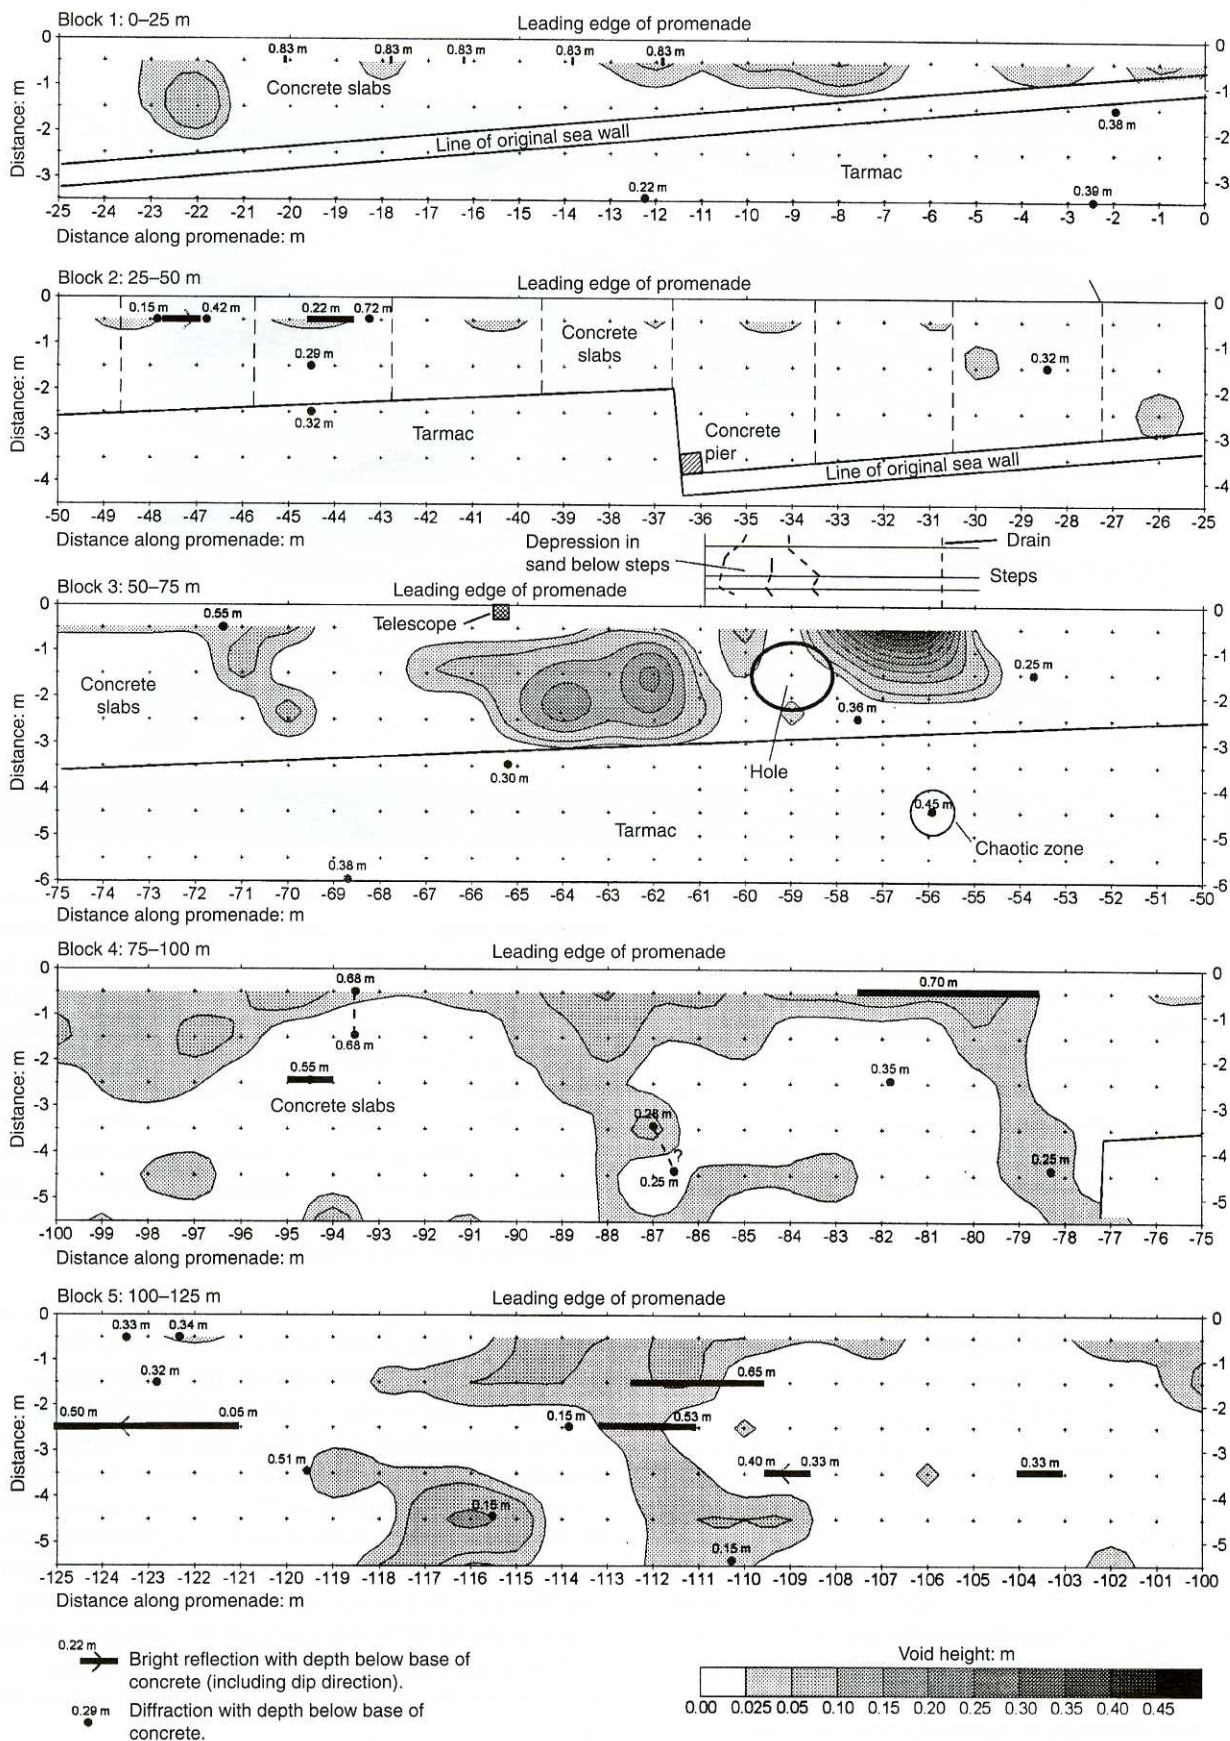
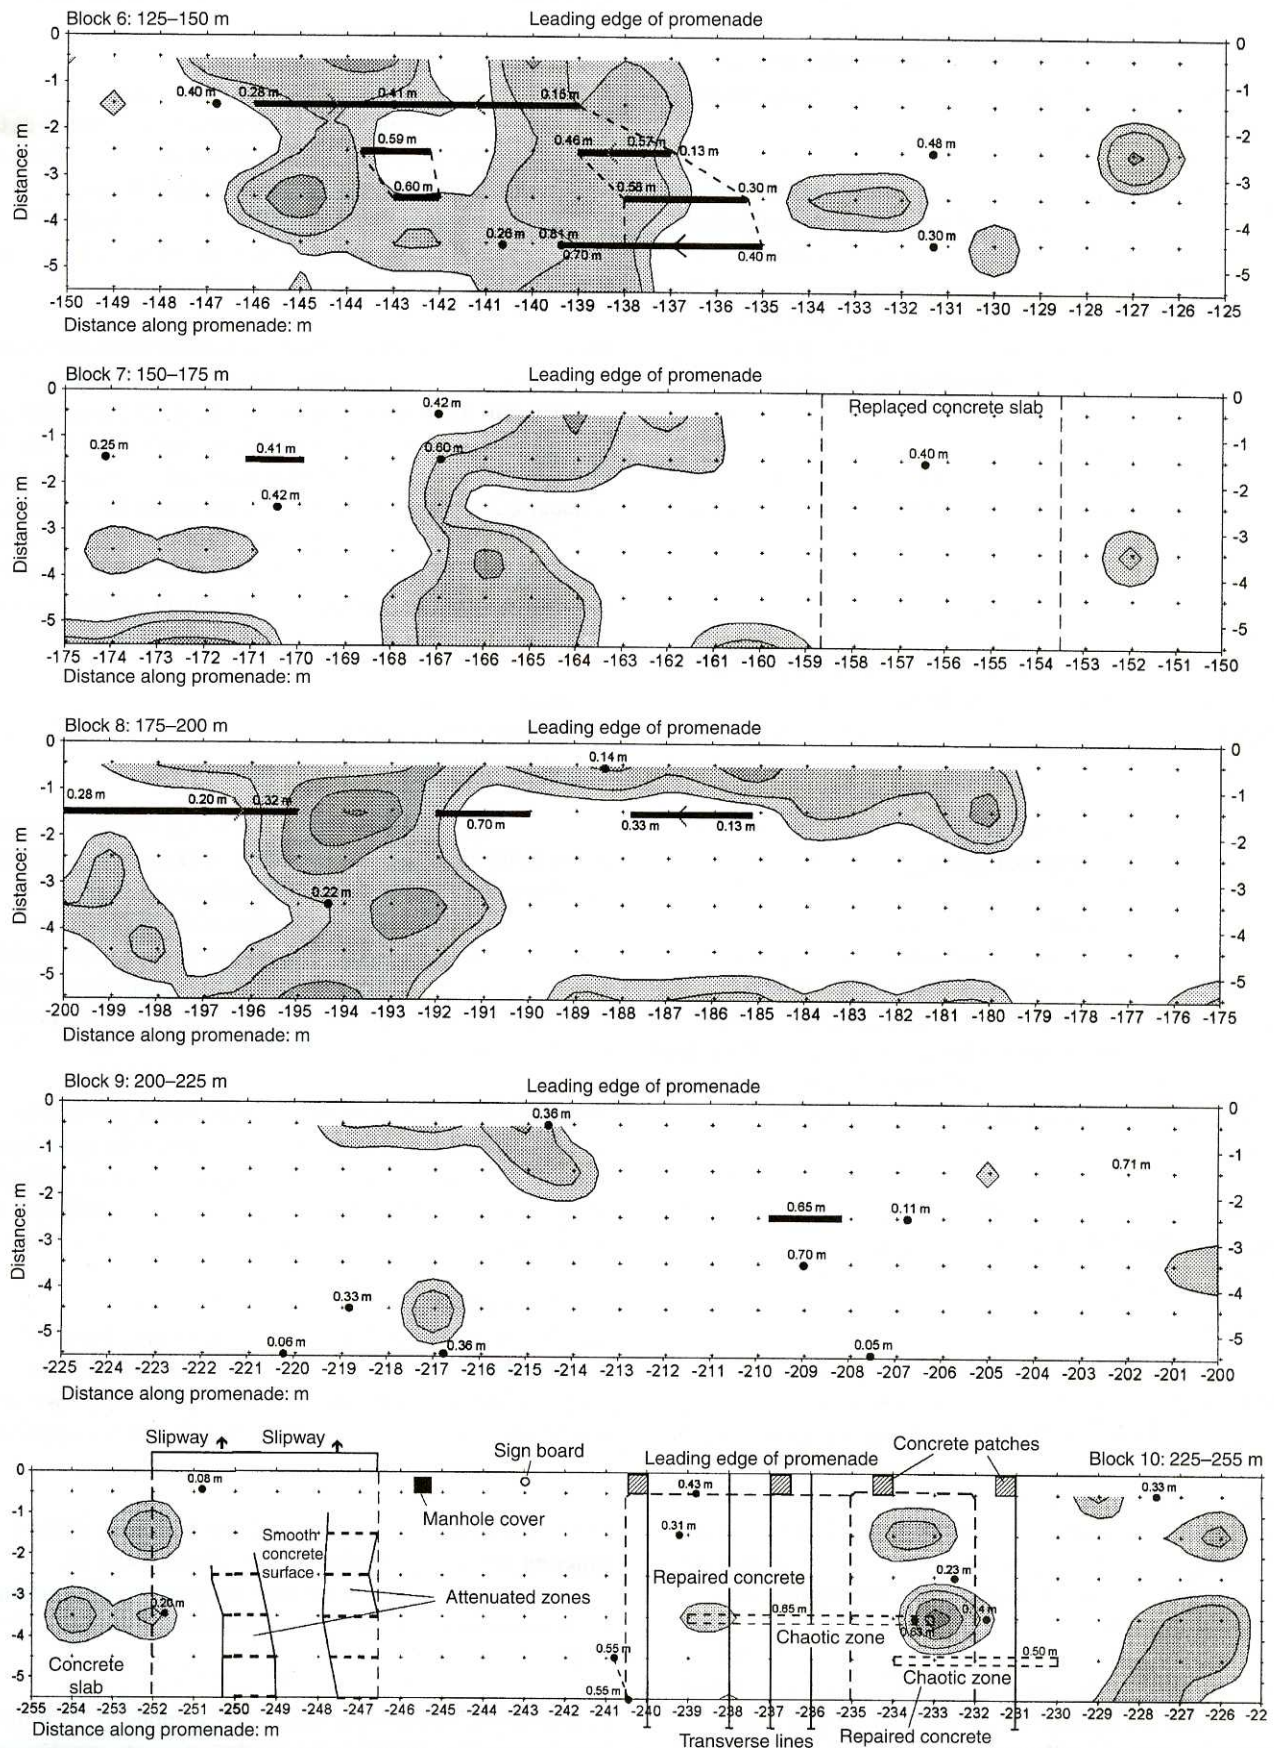
The findings of the ground-penetrating radar survey along the entire East Promenade are presented in Fig. 8 as a series of block maps labelled 1–10 inclusive. The maps depict interpreted void heights from zero through to over 0.45 m. The positions of prominent diffractions are marked, together

Fig. 8. Model of interpreted void dimensions along the East Promenade (continued opposite)

Noteworthy features from Fig. 8 include the absence of voids under the tarmac area, the concentration of void development alongside the seaward edge of the concrete slabs and within the middle of certain slabs.

In block 3, the position of the known cavity is labelled. The void size appears minimal at the site of the collapse because the hole was backfilled with sand to the same level as that of the concrete slab. However, areas of void remain on both sides of the site.

In block 6, two features require explanation. First, the blocky distribution of the interpreted voids; this pattern correlates with individual concrete slabs which typically measure about 3 m wide. Second, the inclined reflections which dip westwards around the position -137 m; these have the appearance of a dipping sand-dune face and may represent a former natural surface that has been built over. Conceivably, the inclined reflections relate to a former collapse area where sand has been backfilled into a cavity but this explanation seems difficult to reconcile with the absence of any significant sub-slab voiding greater than the 0.1 m detected.

In block 8, another area of shallow sub-slab voiding is apparent around position -194 m and approximately 1.5 m from the edge of the promenade. This area also underlies a single concrete slab.

In block 10, two slabs of concrete have previous repairs and here the radargrams reveal two noteworthy features. First, a possible cavity with a void height of up to 0.2 m occurs at position -233 m and approximately 3.5 m from the edge of the promenade. Second, narrow zones of chaotic reflections are present between depths of 0.5 and 0.65 m below the base of concrete slabs. These features may relate to former collapse features that necessitated the repairs to the slabs.

Also in block 10, the slabs between Rhyll Lifeboat Station and the slipway have a smooth concrete surface and, within this area, two distinctive zones of attenuated radar signals are evident on the radargrams at shallow depths around positions -247 m and -250 m. It is speculated that these two zones relate to the axle width of the trailer used to deploy the lifeboat. The weight of the transporter carrying the boat may apply sufficient load to the ground to reduce the local soil moisture content and thereby

Minor repair works were performed along severely cracked zones on the running surface around blocks 4 and 10. Inspections carried out during these repairs generally confirmed the dimensions of the sub-slab voids and verified the radar results.

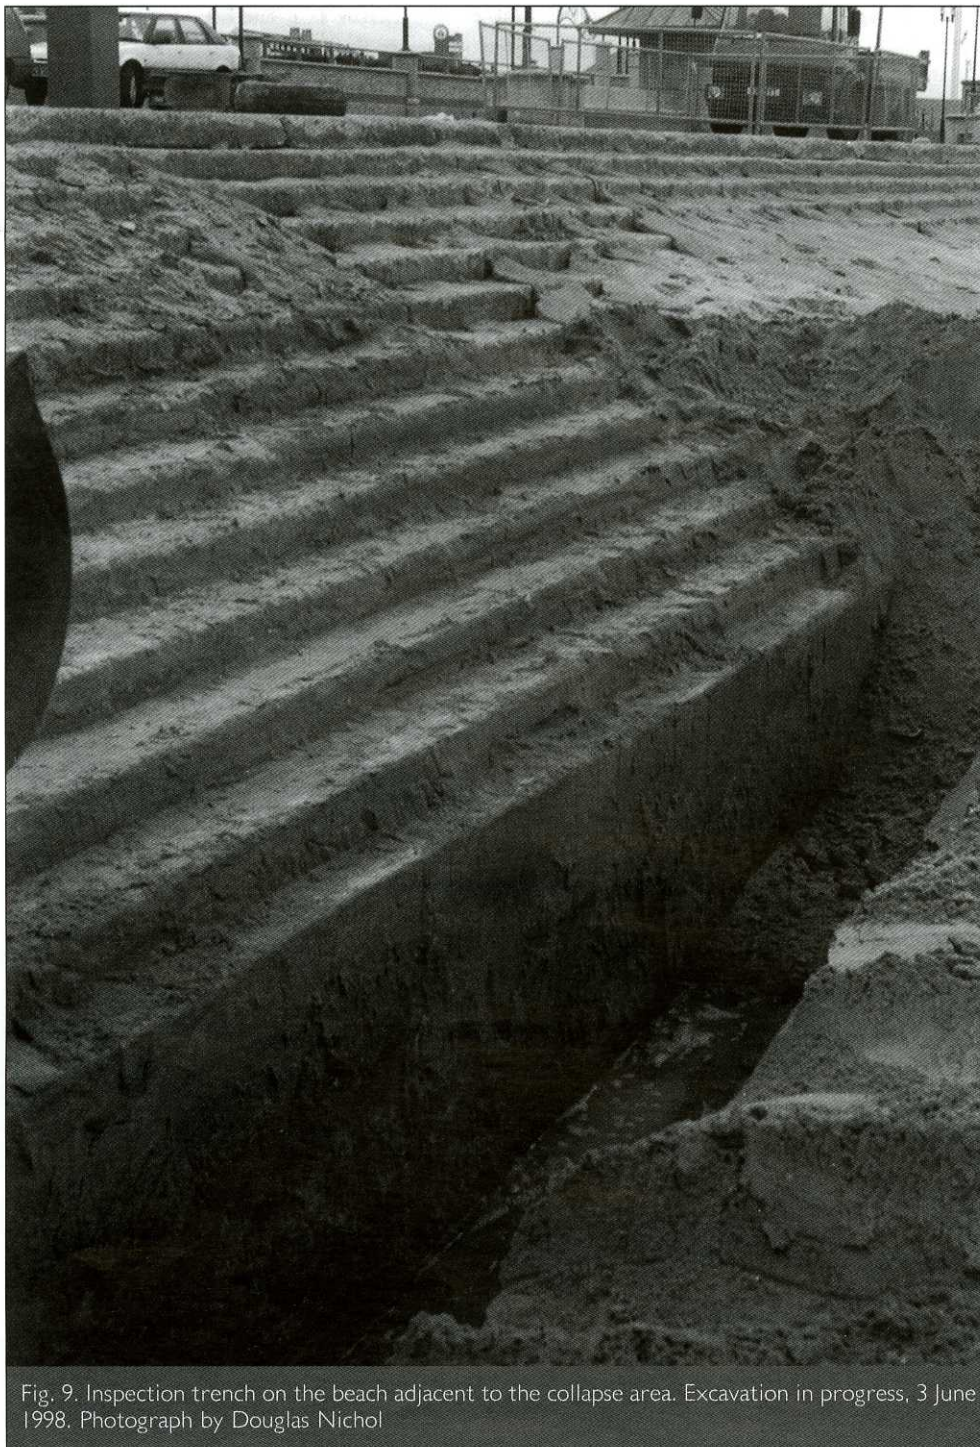
Subsequent excavation of the known cavity provided physical access to the nearby drainpipe which outfalls on the seventh step immediately to the east of the collapsed area. The condition of the sand around the pipe was observed to be compacted and undisturbed. In addition, an inspection trench was excavated on the beach to uncover the buried steps and lower sea wall adjoining the collapsed area (Fig. 9) but here too, no defects were identified.

Fig. 9. Inspection trench on the beach adjacent to the collapse area. Excavation in progress, 3 June 1998. Photograph by Douglas Nichol
