On the need to integrate Disaster Risk Management within the hydropower sector

John M. Reynolds

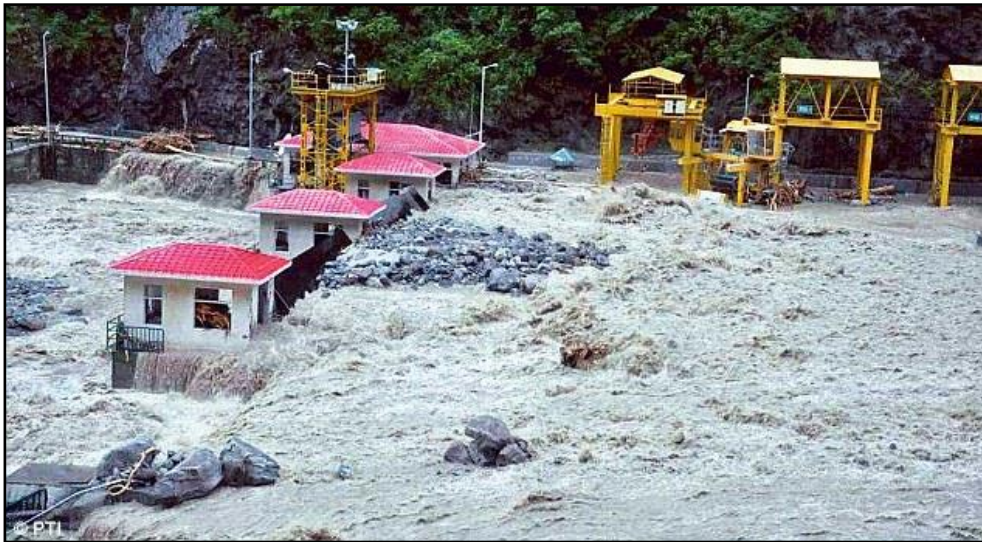
Figure 1: Vishnuprayag Hydropower Plant sluice gates being inundated and destroyed by the floods in Uttarakhand, northern India, in June 2013. (Image courtesy of www.thehindubusinessline.com).

In June 2013 in Uttarakhand in Northern India, over 450 mm of rain fell in 60 hours triggering landslides and debris flows resulting in the loss of over 5,000 lives and massive damage over a very wide area. The sluice gates of the 400 MW Vishnuprayag HEP scheme on the Alaknanda River were largely destroyed (Figure 1). The event transported more than the total annual sediment flux of the catchment through this river system during the floods over four days, significantly modifying the sediment load characteristics of this river.

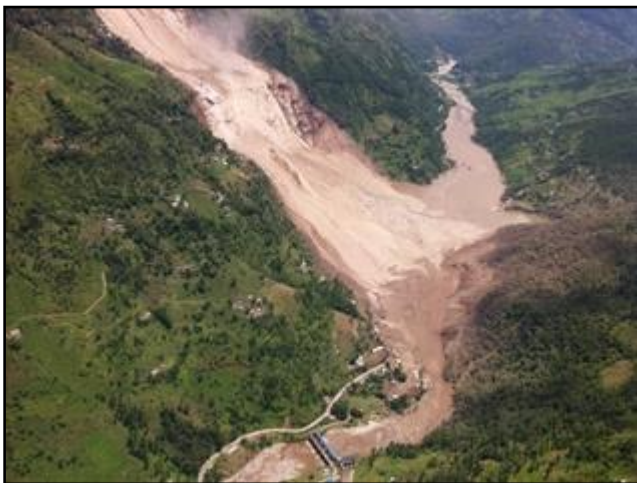
Figure 2: The landslide and the dam it formed across the Sun Kosi River, August 2014. The 10 MW Sun Kosi HEP sluice gate structure can be seen in the bottom centre of the picture. (Image courtesy of www.heraldsun.au).

On 2nd August 2014, a major landslide crashed down onto a village and blocked the Sun Kosi River in Sindhupalchowk District, about 60 km from Kathmandu in Nepal (Figure 2). The landslide dam impounded the river, the level of which rose rapidly and formed a large lake upstream. Several villages situated along the river were evacuated. The dam was artificially breached but the ensuing flood caused significant damage downstream. In addition to killing over 150 people, the event resulted in damage to 67 MW of hydropower infrastructure, reducing the country's installed capacity by 10% and increasing load-shedding in Kathmandu by 1½ hrs per day.

It was reported that had the debris been cleared at the sluice gates before discharging the water in the landslide lake not all of the gates would have been blocked. As four out of the six sluice gates were blocked following the landslide dam discharge, the river has been eroding the river bank at the northern side of the dam gates threatening further damage to the structures. It was estimated in September 2014 that the project would be generating again at full capacity within a year.

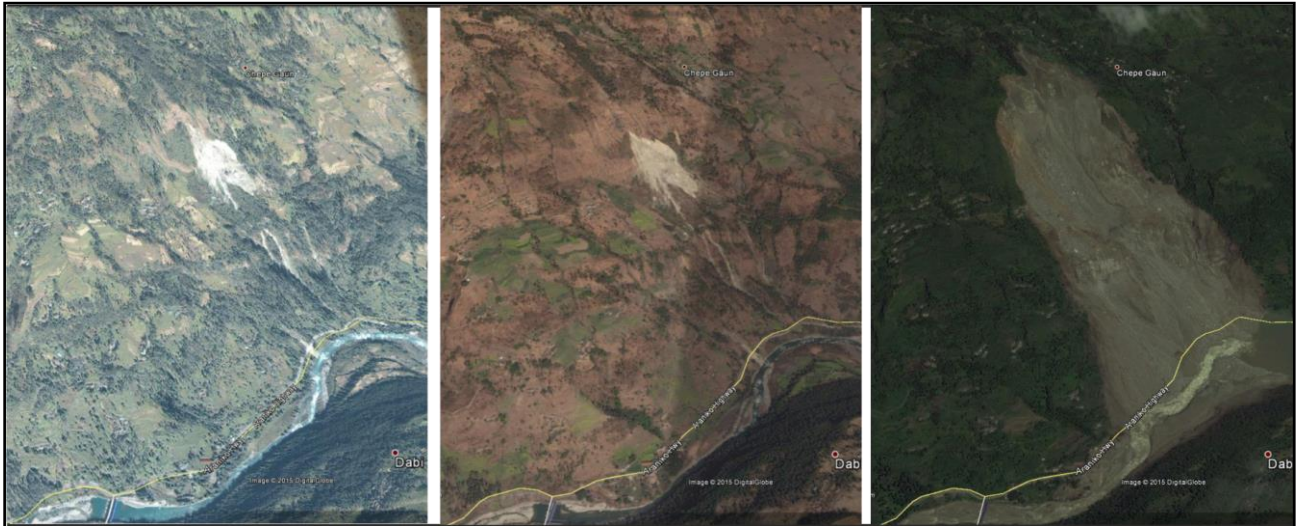
Figure 3: The development of the Sun Koshi landslide between (*left*) 31st October 2009; (*middle*) 13th February 2013; and (*right*) 10th August 2014, eight days after the disaster. The location of the Sun Kosi HEP sluice gate structure can be seen across the river in the lower left of each image. (Images extracted from Google earth – © DigitalGlobe).

From examination of available satellite imagery of the Sun Kosi landslide site from as early as March 2004 there are signs of early stage slope movement that can be seen to have developed further by 6th October 2012. An upper backscarp continued to develop through into February 2013 prior to total failure on the 2nd August 2014. A sequence of images extracted from Google earth scenes is shown in Figure 3. The earlier slope movements appear to have been surficial failures with the fatal event being initiated further upslope and being deeper seated. The question has to be asked – why were these early signs of slope failure not identified at the time and reported so that the hillside could have been investigated, especially given the proximity of the 43-year old 10 MW Sun Kosi HEP plant and local communities? This highlights a dilemma for the hydropower industry. How far from a particular HEP site do site-specific responsibilities extend up- (and down-)stream? Is landslide potential a responsibility of the Nepalese Government to map and determine (*e.g.* Department of Geology and Mines)? If so, how is the information about risk shared with communities and HEP plant operators and under which national policy/ies does this communication coordination fall, if any?

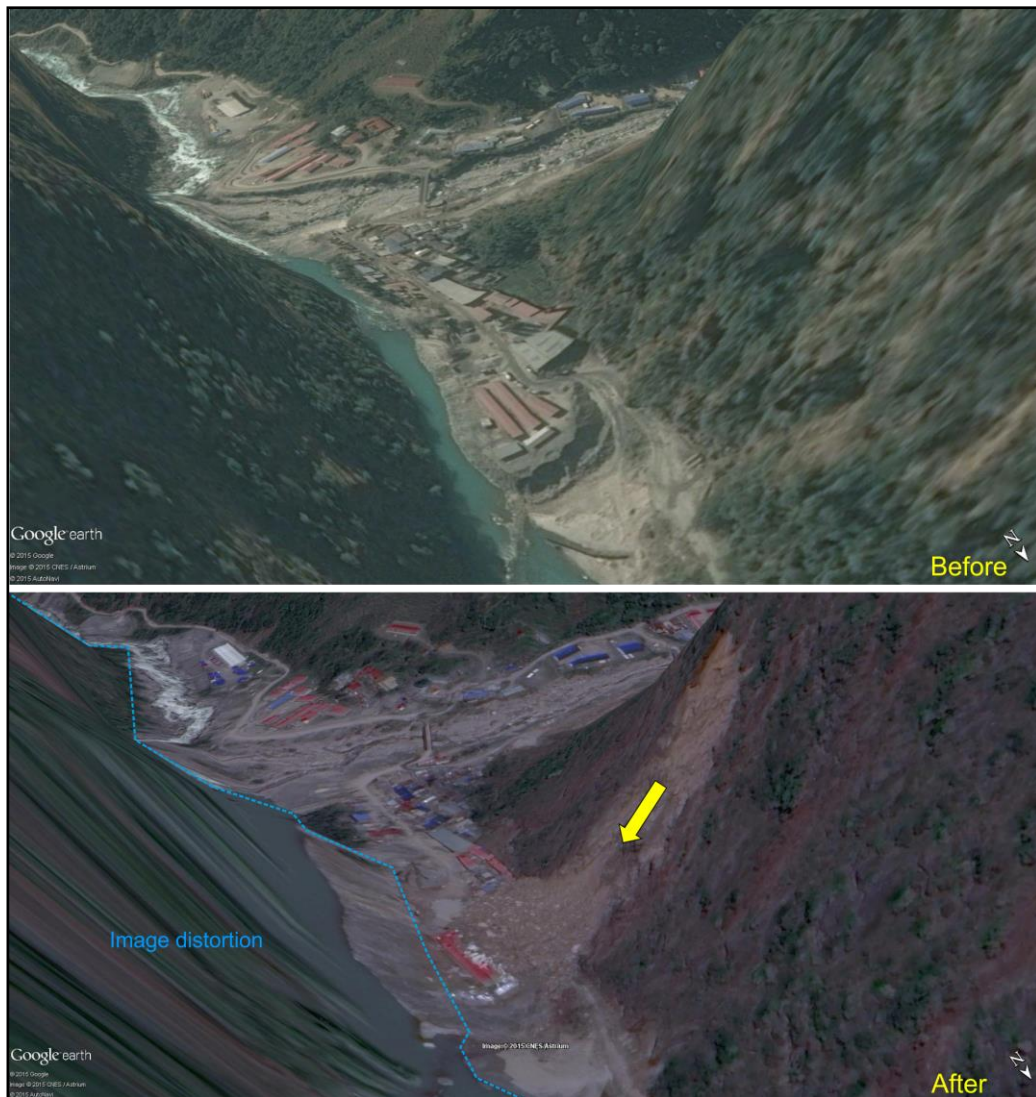
Figure 4: The village of Gongar beside the Tama Kosi River, Dolakha District, Nepal, shown (*top*) before and (*bottom*) after the Gorkha earthquake of the 25th April 2015. (Oblique images derived from Google Earth imagery).

One of the landslides south of Lamabagar HEP plant at Gongar Village, Dolakha District, is shown (viewed towards the south) in Figure 4 with the same area before and after the earthquake on the 25th April 2015. The access road built for the Upper Tama Kosi HEP project at Lamabagar can be seen to the west of the river. A set of large buildings (in the lower centre of the top picture) was almost completely buried by the landslide, which also blocked the access road.
