PROCEEDINGS OF
THE INSTITUTION OF
CIVIL ENGINEERS

Ground-penetrating radar survey to detect sub-slab voids beneath the East Promenade at Rhyl

D. Nichol and J. M. Reynolds

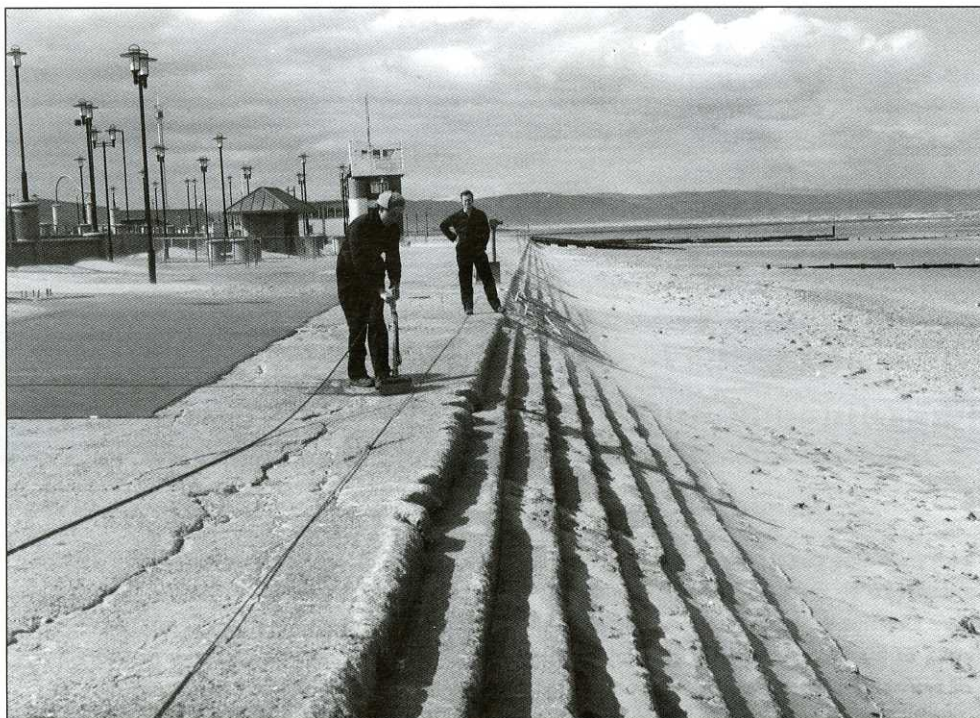
Fig. 2. The East Promenade at Rhyl looking westwards. Ground-penetrating radar survey in progress, 17 April 1998. The mountainous terrain of Snowdonia forms the background. Rhyl Lifeboat Station lies in the middle distance and the Sun Centre is situated to the left of the picture. Photograph by Douglas Nichol
